**DEFENSE NUCLEAR FACILITIES
SAFETY BOARD**

Staff Issue Report

January 29, 2016

SUBJECT: Seismic Qualification of Fire Suppression System at the Plutonium Facility, Los Alamos National Laboratory

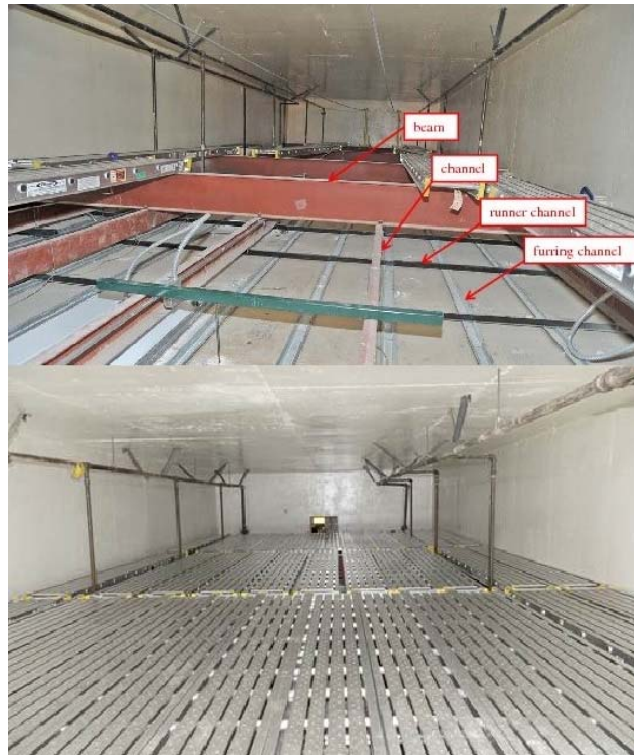
Configuration Changes to Laboratory Ceilings—During walkdowns of PF-4, the staff review team viewed one of the laboratory ceiling spaces where LANS has made fire suppression and structural upgrades to the roof girders. Damage or collapse of parts of the laboratory ceiling during an earthquake may damage fire suppression piping and prevent the proper heat activation of sprinkler heads during a post-seismic fire. The staff review team noted that LANS installed significant metal decking that is supported by the laboratory ceiling (Figure 2). This differs from the facility configuration assumed in the seismic evaluation performed in 2011 by LANS's subcontractor [6]. Facility engineers told the staff reviewers that these changes are intended to be permanent.

When asked if this significant increase in dead load and seismic mass added to the laboratory ceilings had been accounted for, LANL staff engineers said that they had not updated this calculation with the configuration changes made since 2011, but believed the added decking would not exceed the dead load assumptions used in the calculations. In further discussions, LANS engineers estimated that the metal decking mass will not challenge the assumed miscellaneous loads on the laboratory ceiling. This condition was not formally evaluated before installation of the decking, and is a lapse in configuration management of the laboratory ceiling. The *Nuclear Safety Management Rule* (10 CFR Part 830) requires evaluating the impacts of configuration changes on safety-related SSCs before they are made [7]. Consistent with the rule, the staff believes that unanalyzed conditions, such as the metal decking, should have been evaluated through the LANS Unreviewed Safety Question process.

Figure 2: Condition of laboratory ceiling as evaluated (top) and current configuration (bottom).
