**October 9, 2006**  
**REDUCING THE RISKS OF HIGHLY ENRICHED URANIUM AT  
THE U.S. DEPARTMENT OF ENERGY'S Y-12 NATIONAL  
SECURITY COMPLEX**

by  
**Robert Alvarez**  
**Senior Scholar**  
**Institute for Policy Studies**

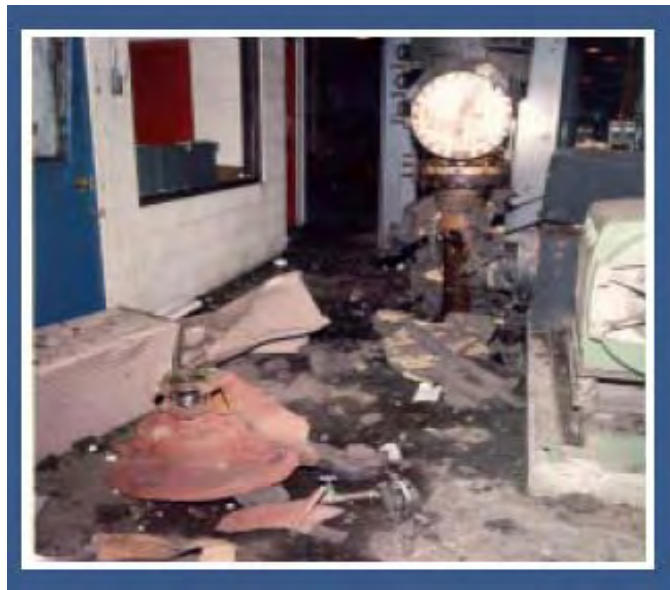
**Figure 6 Destruction Caused by Coolant Pump Explosion at the Y-12 Complex in August 1998**

- Hundreds of thousands of gallons of an ignitable mixture of methanol/water coolant flows through several buildings at Y-12. Vapor ignition temperatures range between 75 degrees to 95 degrees Fahrenheit. In August 1998, a large coolant pump at the Y-12 Chiller building exploded, causing extensive damage to nearby equipment and structures, and injuring a worker in another room. According to DOE, “This occurrence was a very serious near miss, as anyone in the unprotected area near the pump could have been seriously or fatally injured.”<sup>66</sup> (See Figure 6.)

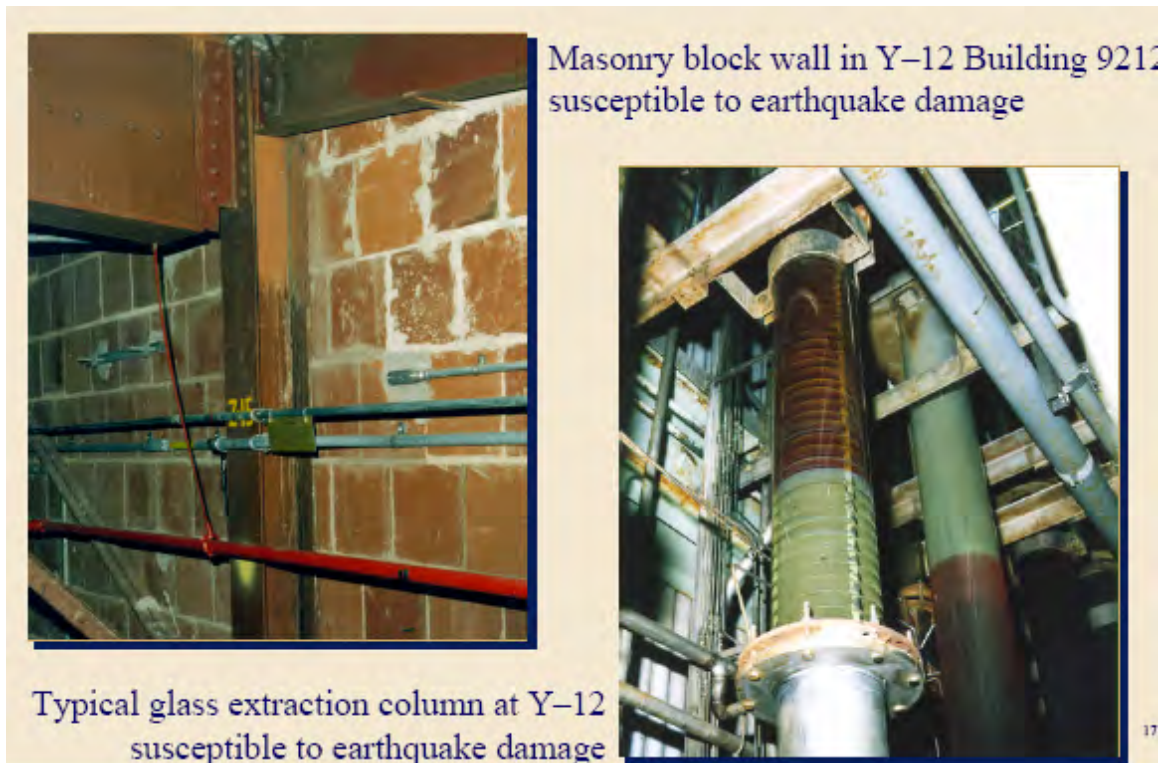
**Figure 8**

*“...numerous seismic deficiencies, including missing or loose bolts, missing or structurally inadequate braces, inadequate beam supports, and designs that are deficient when measured by current criteria. In these aging structures, glass sections in tall columns and sight glasses are vulnerable to breakage, cans on storage racks are not adequately secured, and horizontal and vertical tanks are not adequately supported.”*<sup>193</sup>

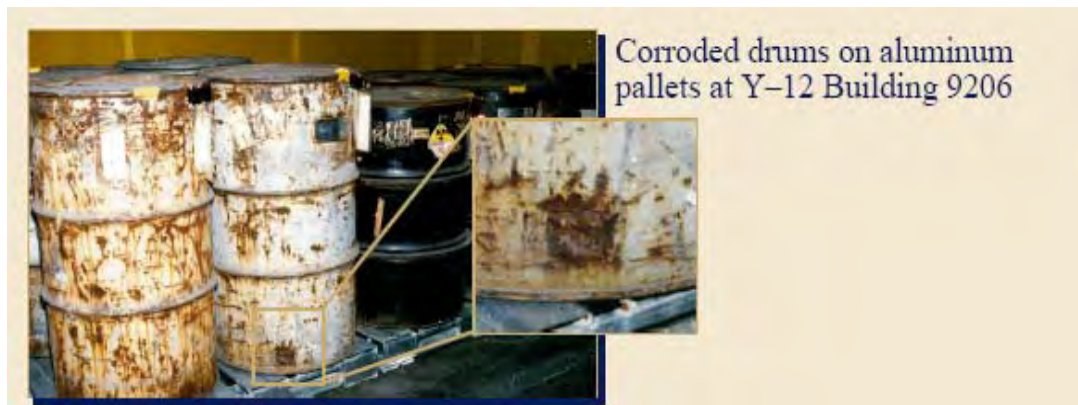
**Figure 9**

HEU solutions and solid residues are less stable chemically and were found to dominate material/ packaging vulnerabilities at the Y-12 plant. *“Large amounts of HEU materials are stored in Building 9212 in unsealed containers, both liquids and solids. Typically, solids in the form of chips and powder re contained in cans with slip-fit lids and liquids are stored in bottles with untightened caps...there is no barrier between HEU and the environment...there is no containment barrier between HEU material and workers. Moreover, there are few constant air monitors to warn workers.”*<sup>194</sup> (See Figure 9.)

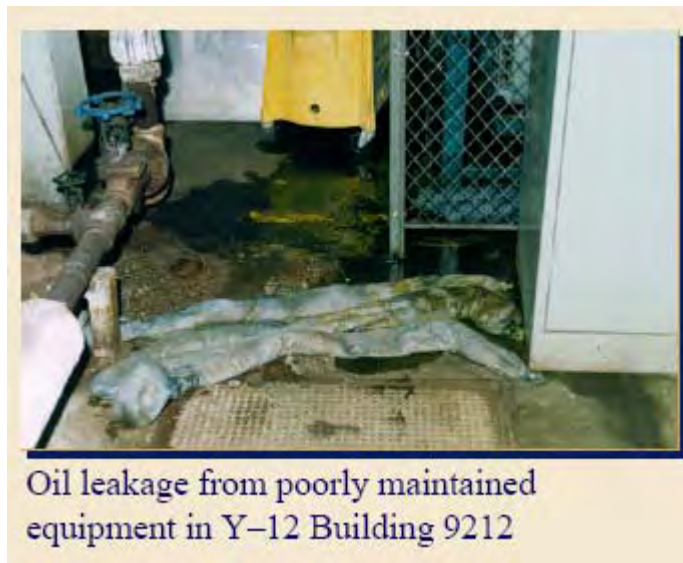
**Figure 10**

**Maintenance Backlog** –A significant and large backlog of maintenance of facilities and equipment essential to the safe operation of Y-12 Plant was of major concern. Specifically, Y-12 was found to have a backlog of 18,000 maintenance items. <sup>220</sup> (See Figure 10.) For instance, the inability to properly maintain storage containers containing pyrophoric HEU materials can lead to leaks, fires and explosions. It also can translate into the malfunctioning of equipment leading to an accidental release of radioactivity, and contamination of onsite or offsite areas. The assessment noted an absence of preventative maintenance relative to fire sprinklers, which *“could add to the likelihood that a fire would occur and also the severity of the fire.”* <sup>221</sup>
