# LANL Investigation Report: Investigation of Two Separate Worker Injuries and Resultant Internal Contamination

February 23, 2007

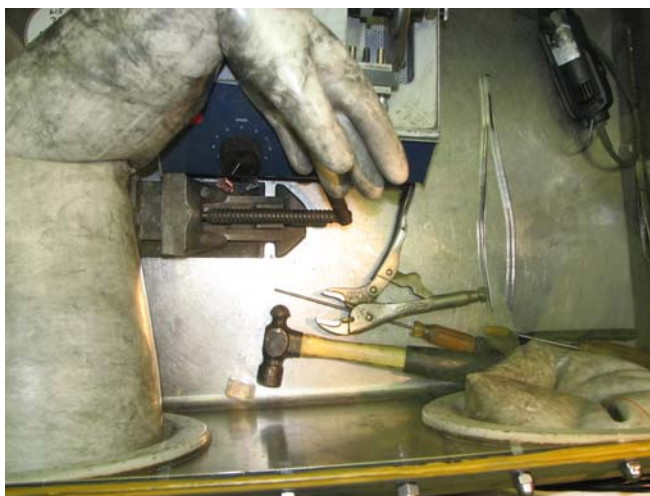
Handtools used by SM. Screwdriver is visible.

to remove a tightly adherent clump when the material suddenly gave way. The screwdriver ricocheted off the vise, and the tip of the screwdriver struck his left index finger tip. He knocked the dangling piece of epoxy from the metal sample and then dropped the sample in the acetone bath. He inspected the left-hand glove and was at first unsure whether it had been punctured. He began to experience pain at the location struck by the screwdriver. In accordance with standard practice at CMR, there was not a second person in the room to render or summon assistance (in contrast with requirements contained in CMR-NOTICE-017). SM removed his right hand from the glovebox glove and surveyed it; no contamination was detected. Peering down the left glovebox glove, he saw a spot of blood. SM slowly removed his left hand from the glovebox glove, doffing his outer surgeon's glove and leaving it inside the glovebox glove. SM clenched his left hand into a fist, completely withdrew it from the glovebox, and surveyed it; no contamination was detected. At about 15:35, SM went to the phone in the adjoining room (2134) to summon assistance. He tried to call an RCT, the Area Wing Controller (AWC), and an MST-16 Team Leader (MST16 TL) from another team. Unable to reach any of these people, he then called the other staff member (for whom he had been preparing the samples) and notified him of the punctured glove and finger. SM did not call the CMR Operations Center, whose number was posted beside the phone, but called the RCT because of the close daily working relationship that had been established.

The AIT determined the direct cause of the CMR event was using a screwdriver to scrape the samples without using appropriate personal protective equipment (e.g. leather gloves) as required by the work control document. The screwdriver slipped and punctured the unprotected left index finger of the worker and contaminated the wound with Pu-239.

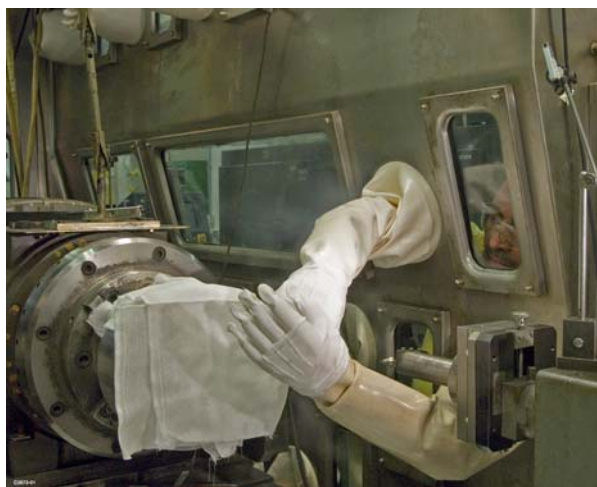
To reposition the part, M1 needed to have his right hand in a glove located at shoulder level and his left hand in a glove located just above his waist. M1 donned his right cotton glove without incident. Next, M1 began donning his left cotton glove. As M1 was tugging on the left cotton glove, his grip on the glove failed and his right hand slipped free. M1's right hand moved forcefully upward and toward the lathe's machining tool. M1's right wrist struck the machining bit with sufficient force to puncture the glovebox glove and penetrate through to M1's skin. M1 did not immediately know that his skin had also been punctured, but did recognize that the glovebox glove had been breached.

**Donning cotton gloves**

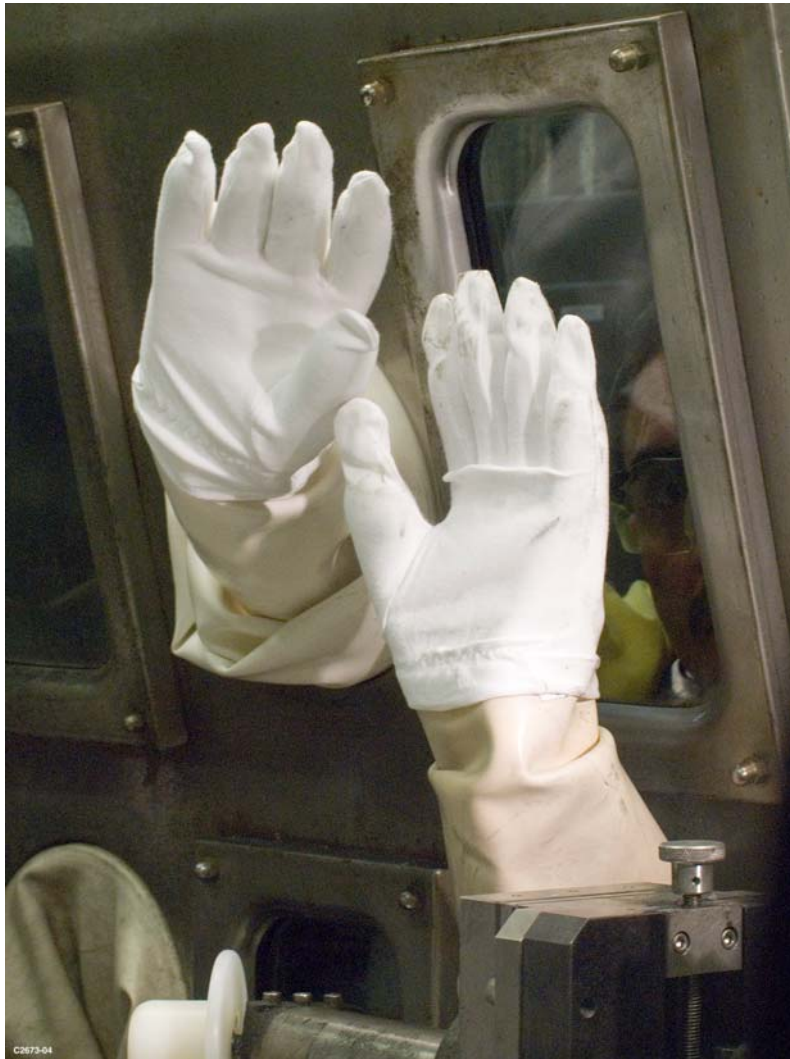
**Figure 7**

The TA-55 facility produces Weapons Components for National Security Missions. These missions are required to follow the requirements of QC-1. QC-1 provides very stringent controls of materials that come in contact with the components. In the June 2002 timeframe the facility instituted the use of cotton gloves. The cotton gloves provide a contamination barrier between the component and the glovebox glove environment. The cotton gloves are worn over the glovebox glove. See figure 7 below.

The gloves are procured to War Reserve (WR) requirements and are used multiple times in the process. The gloves are not difficult to don onto clean glovebox gloves. Members of the investigation team were able to easily don and doff the cotton gloves over the cold glovebox gloves in the PF-39 cold training lab. The investigation team witnessed two TA-55 machinists donning and doffing cotton gloves with ease in the glovebox gloves in

PF-39. As the glovebox gloves wear and / or become engrained with oxides, the cotton gloves become very difficult to don. The glovebox glove is essentially as rough as fine-grit sandpaper. Significant effort is required to don the cotton glove, including a strong pulling motion on the cuff of the cotton gloves. This is the type of pulling motion that is the direct cause of the incident. The approximate configuration of the machinist and the tooling is shown in figure 8 below.

Weapons Component Manufacturing (WCM) is pursuing a removal of the cotton gloves from the process. This action is expected to be complete in the near term and will enhance the safety of the operation. In addition, WCM has designed and built several tool covers. These will be used to shield sharp tools from the glovebox gloves. These actions are planned, but have not been formally implemented.

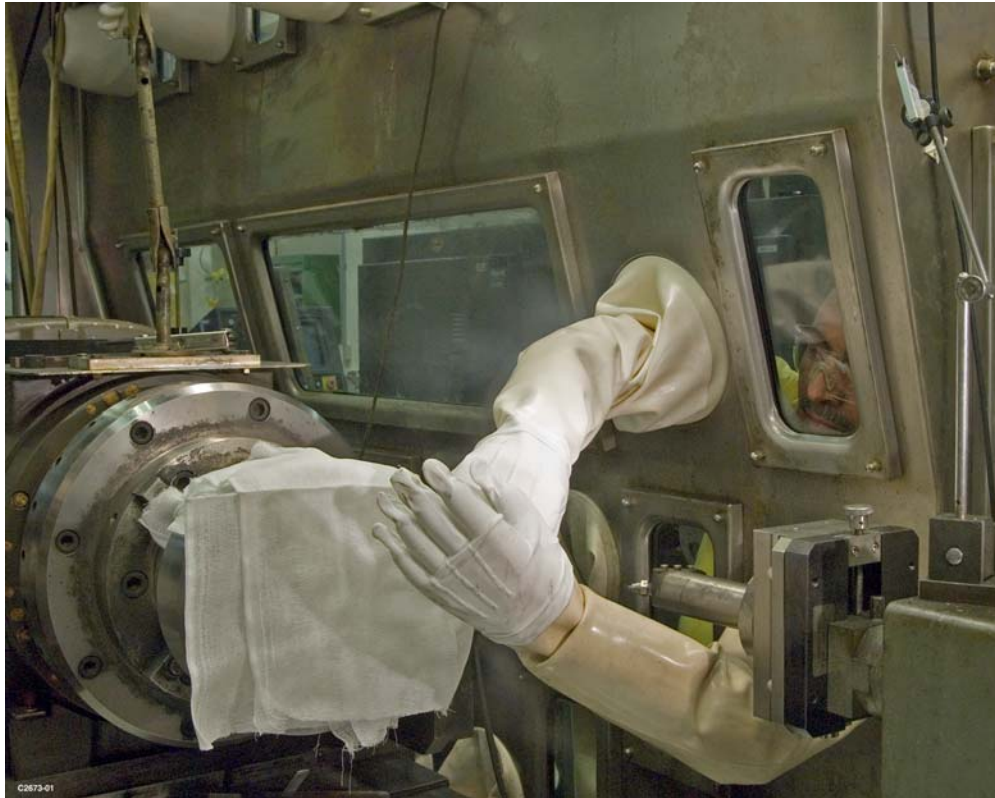
**Figure 8**

The machinist was tugging on the cuff of the left cotton glove when the injury occurred. The right interior wrist is the site of the wound. The force necessary to don the cotton gloves made the strike on the machining bit penetrate through the glovebox glove and the latex gloves worn by the machinist. The wound is the result of the right wrist striking the machining bit in the boring bar shown in figure 9 below.

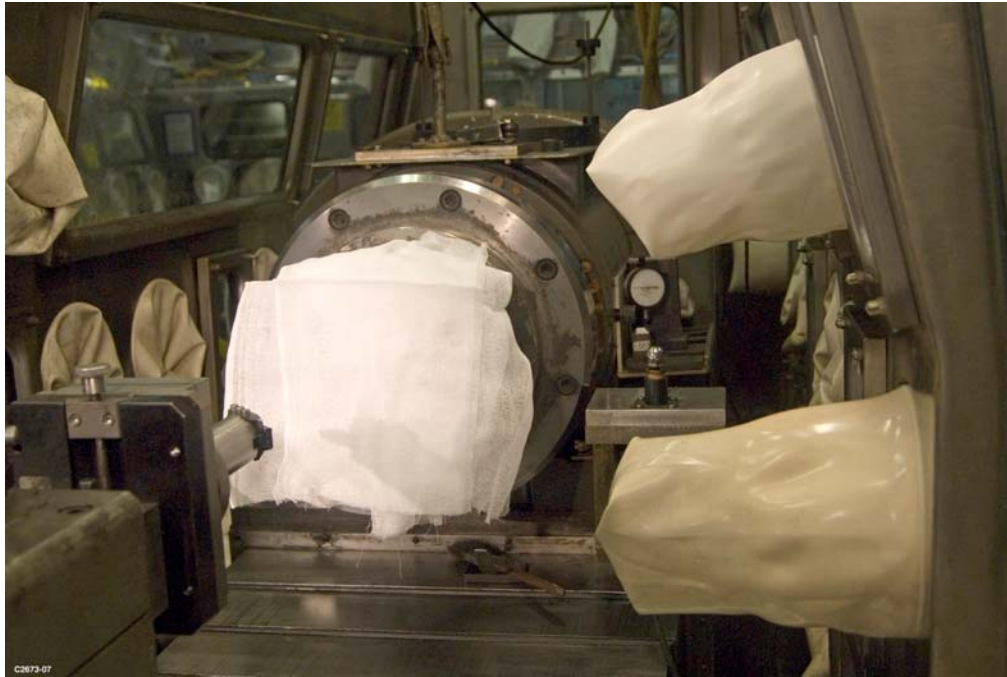
**Figure 10**

The work instruction that is used to machine the component does not include steps that direct the use of the cotton gloves. The procedure does not include any notes or warnings. A typical nuclear facility work instruction or procedure would give specific direction as to when and how the gloves must be used. The TA-55 work instruction did not provide any direction in this regard. Interviews with the personnel involved revealed that the cotton gloves are donned at approximately the same step in the machining process. The interviews also indicated that the position of the boring bar relative to the glovebox gloves was different for different machinists. At least one of the machinists moved the boring bar away from the glovebox gloves prior to donning the cotton gloves. This “Good Practice” was not included as a step in the work instruction nor was it communicated to all personnel. The management team was not aware of this practice. The position of the boring bar in the distant position is shown in figure 10 below.

Compare figure 8 with figure 10. The change in distance is approximately 15 inches. This change in distance from the glovebox gloves would have prevented this incident.
